Manhole Inspection Summary

Manhole # S71M__001MH

Insp Date: **5/20/08 10:45 AM**

Location Address: **1238 Delbert Ave.**

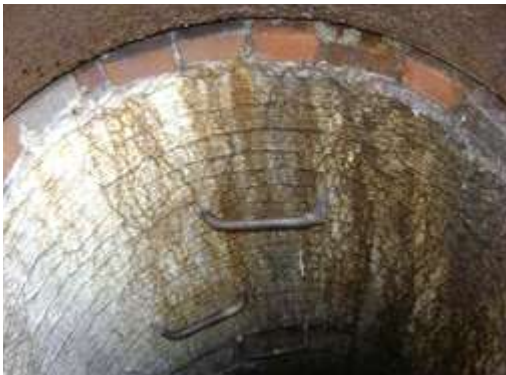
Defect 2

gap at frame seal

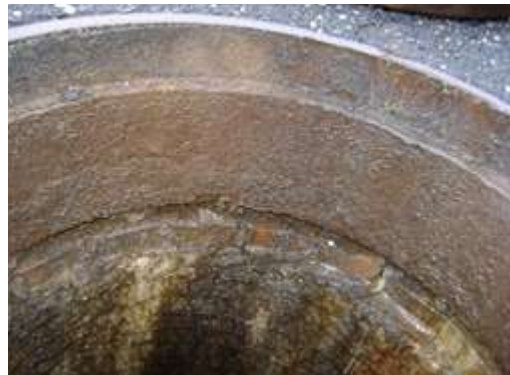
Defect 1

Condition: ☐ Sound ☐ Cracked ☐ Root Intrusion ☒ **Loose Brick** ☒ **Deteriorated**

Infiltration: ☐ None ☒ **Joint** ☐ Cracks ☒ **Mortar** ☐ Roots ☐ Wall

Infiltration in chimney

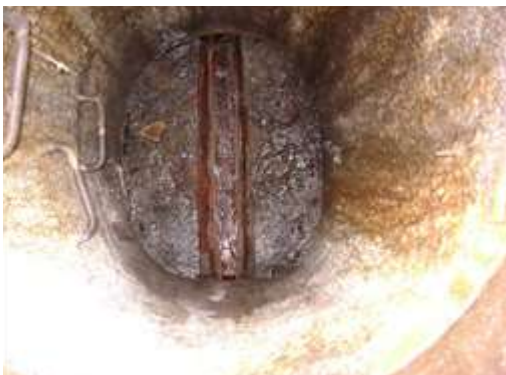
Defect 3

Condition: ☐ Sound ☐ Cracked ☐ Root Intrusion ☐ Deteriorated ☐ Leaks ☒ **Debris**

debris on bench

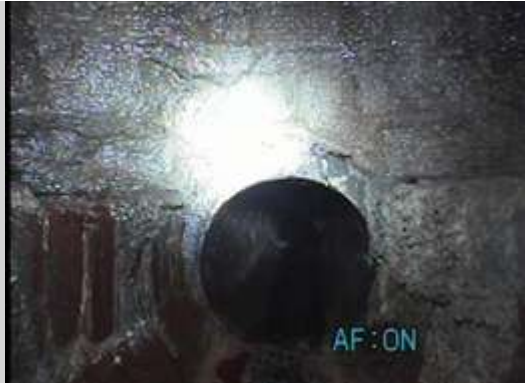
12 O'Clock Outflow

Pipe Height: **8.4** (in.) Rod and Bar (Angled)
Pipe Material: **Clay** ☐ Pipe Lined
Invert Depth: **9.00** (ft.) Flow Characteristics: **Slow**
Deposits: ☒ None ☐ Mud ☐ Sludge ☐ Debris ☐ Grease
Silt Depth: (in.) Deposits Extent:
Infiltration: **None** Pipe Seal Cond: **Sound**

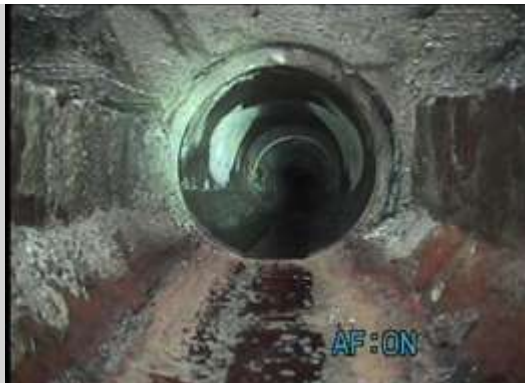
6 O'Clock Inflow

Pipe Height: **8.4** (in.) Rod and Bar (Angled)
Pipe Material: **Clay** ☐ Pipe Lined
Invert Depth: **8.58** (ft.) Flow Characteristics: **Slow**
Deposits: ☒ None ☐ Mud ☐ Sludge ☐ Debris ☐ Grease
Silt Depth: (in.) Deposits Extent:
Infiltration: **None** Pipe Seal Cond: **Sound**
